DRAFT AFTER ACTION REPORT

**Hi-Tech Plating Facility
Balch Springs, Dallas County, Texas**

**EPA - REGION VI
EMERGENCY RESPONSE BRANCH**

**Ecology and Environment, Inc.
Technical Assistance Team**

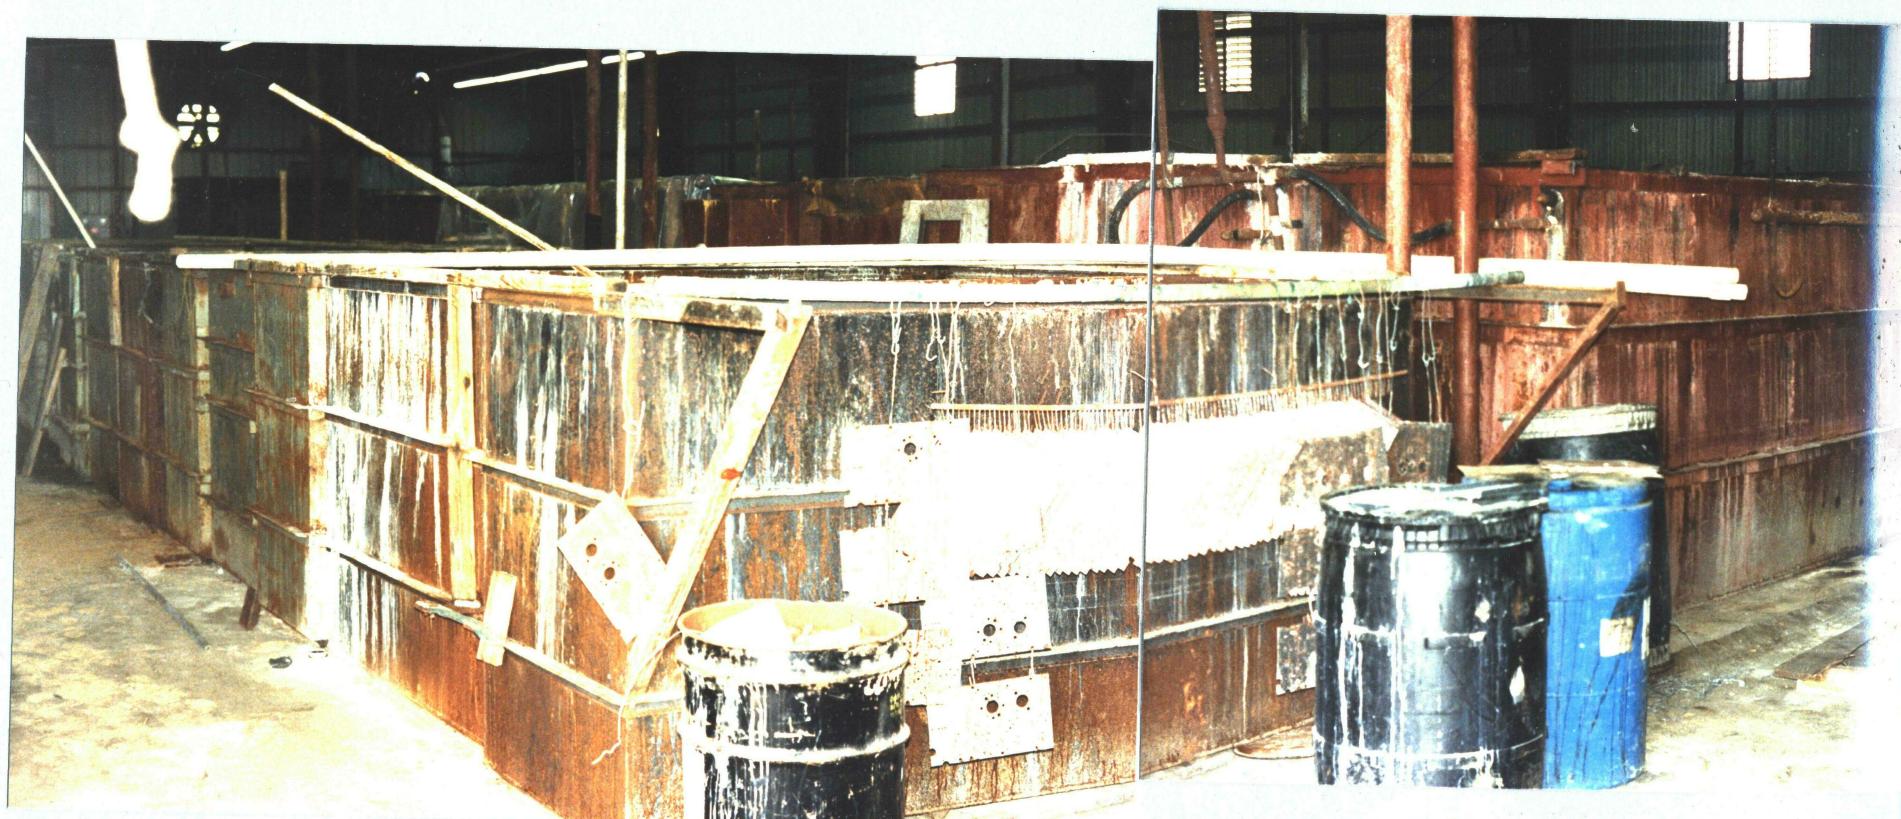
Comments: Pan shot of vats near site

entrance (bay doors).

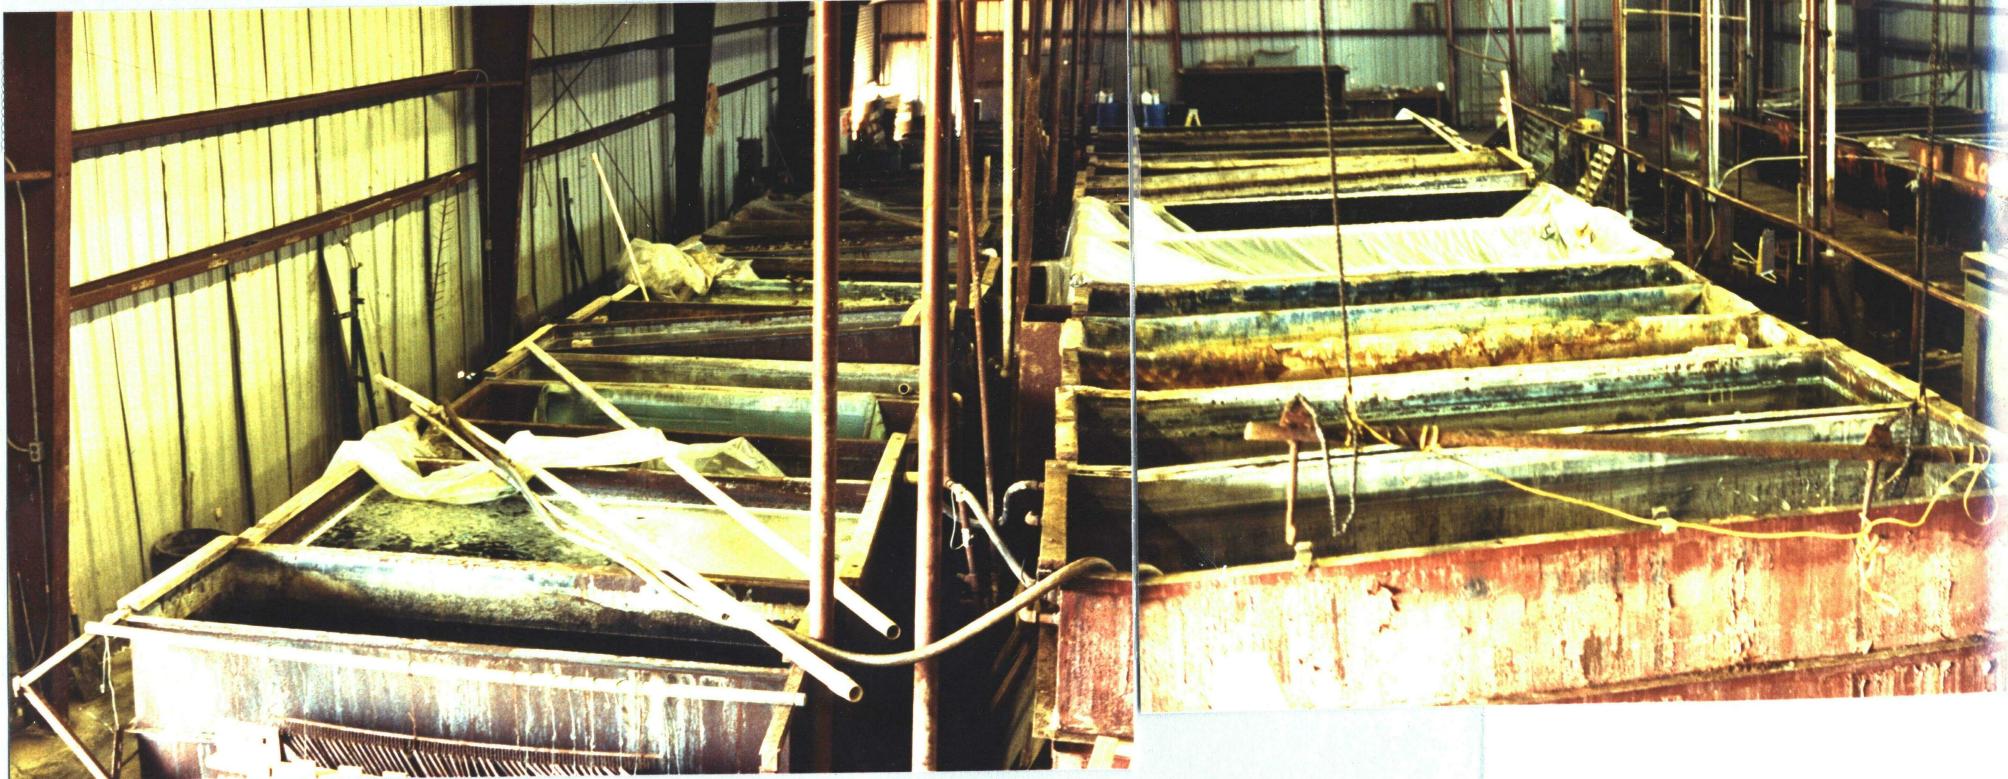
Comments: Pan shot of vats inside building
before removal actions began. Vats suspected
of containing cyanide were covered with visqueen
to reduce evolving vapors.

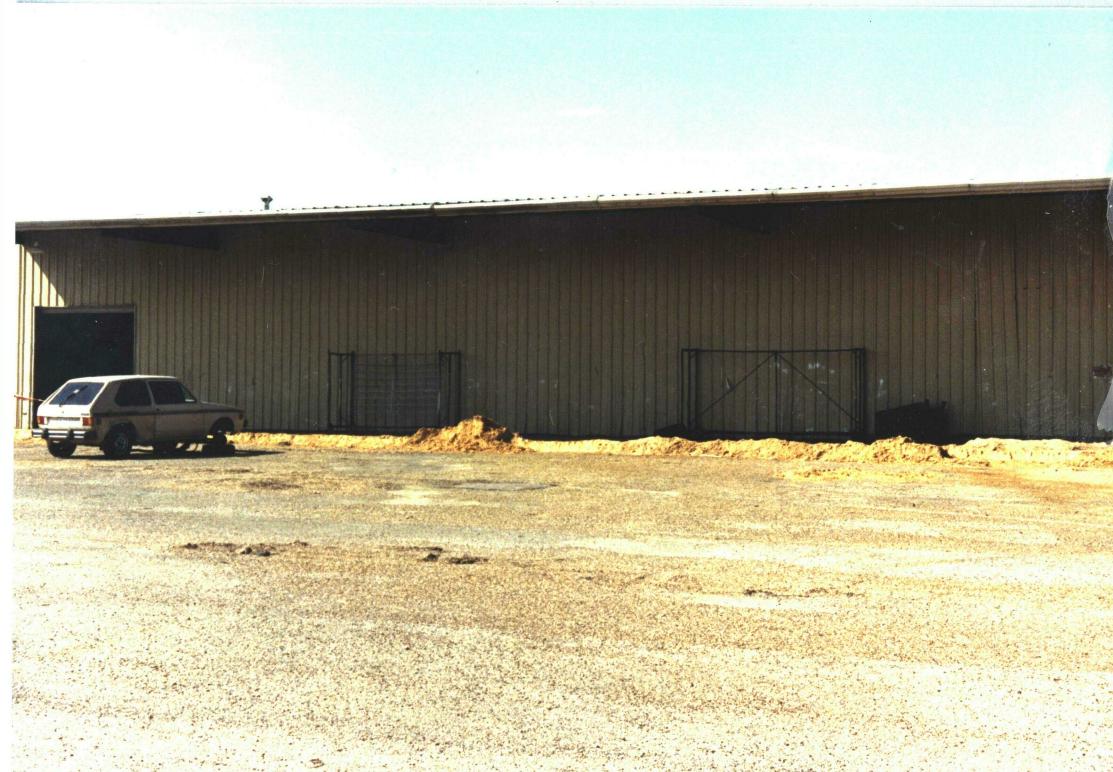
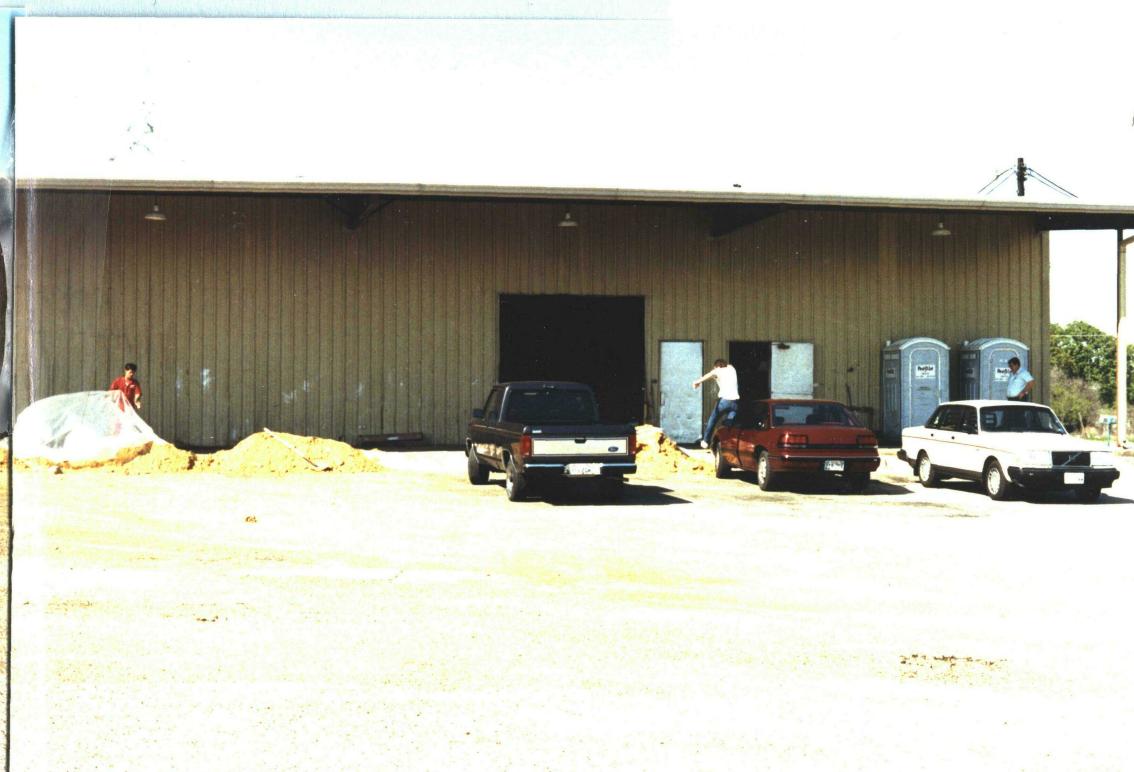
Comments: Pan shot of berm erected by ERCS
to control any potential leaks from vats.

After the initial stabilization actions were taken by the PRP, the ERCS contractor was mobilized to the site on 3 April 1990. On this date, ERCS constructed a sand berm around the downslope portion of the site to prevent any further leaks from migrating offsite(Photo page # 4). During the week of 3-10 April 1990, the

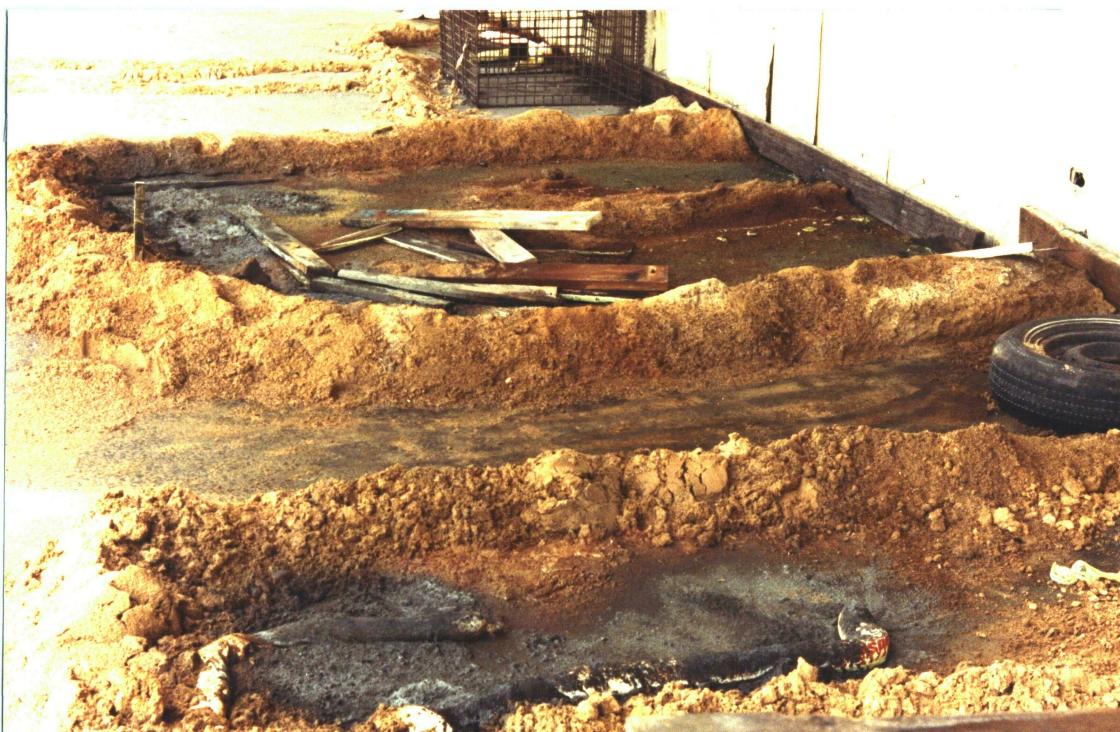
Comments: Containment berm on north side of building drainage.

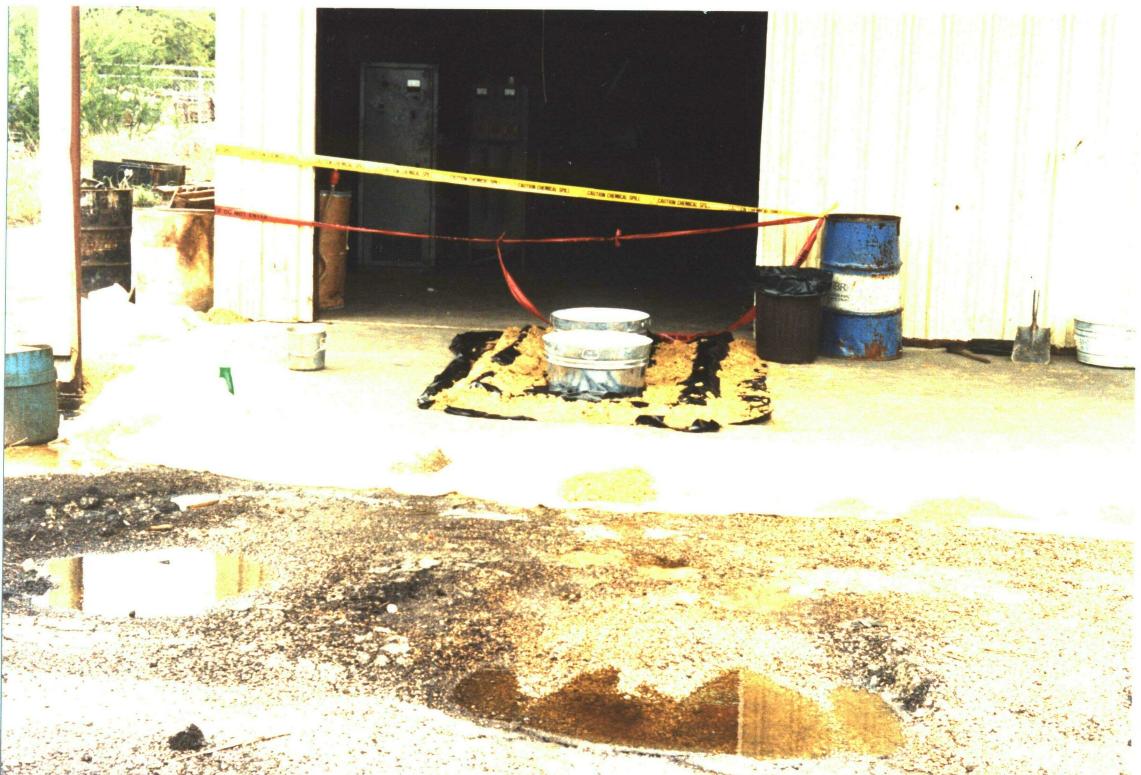
Comments: Berm erected by ERCS to contain spill from leaking vats on south end of building.

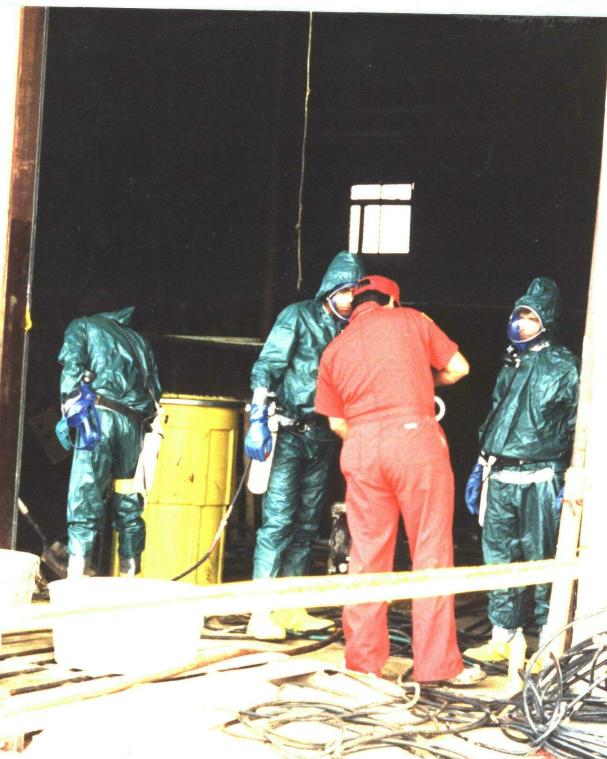
Comments: Crew using absorbent material
to contain leak from vat.

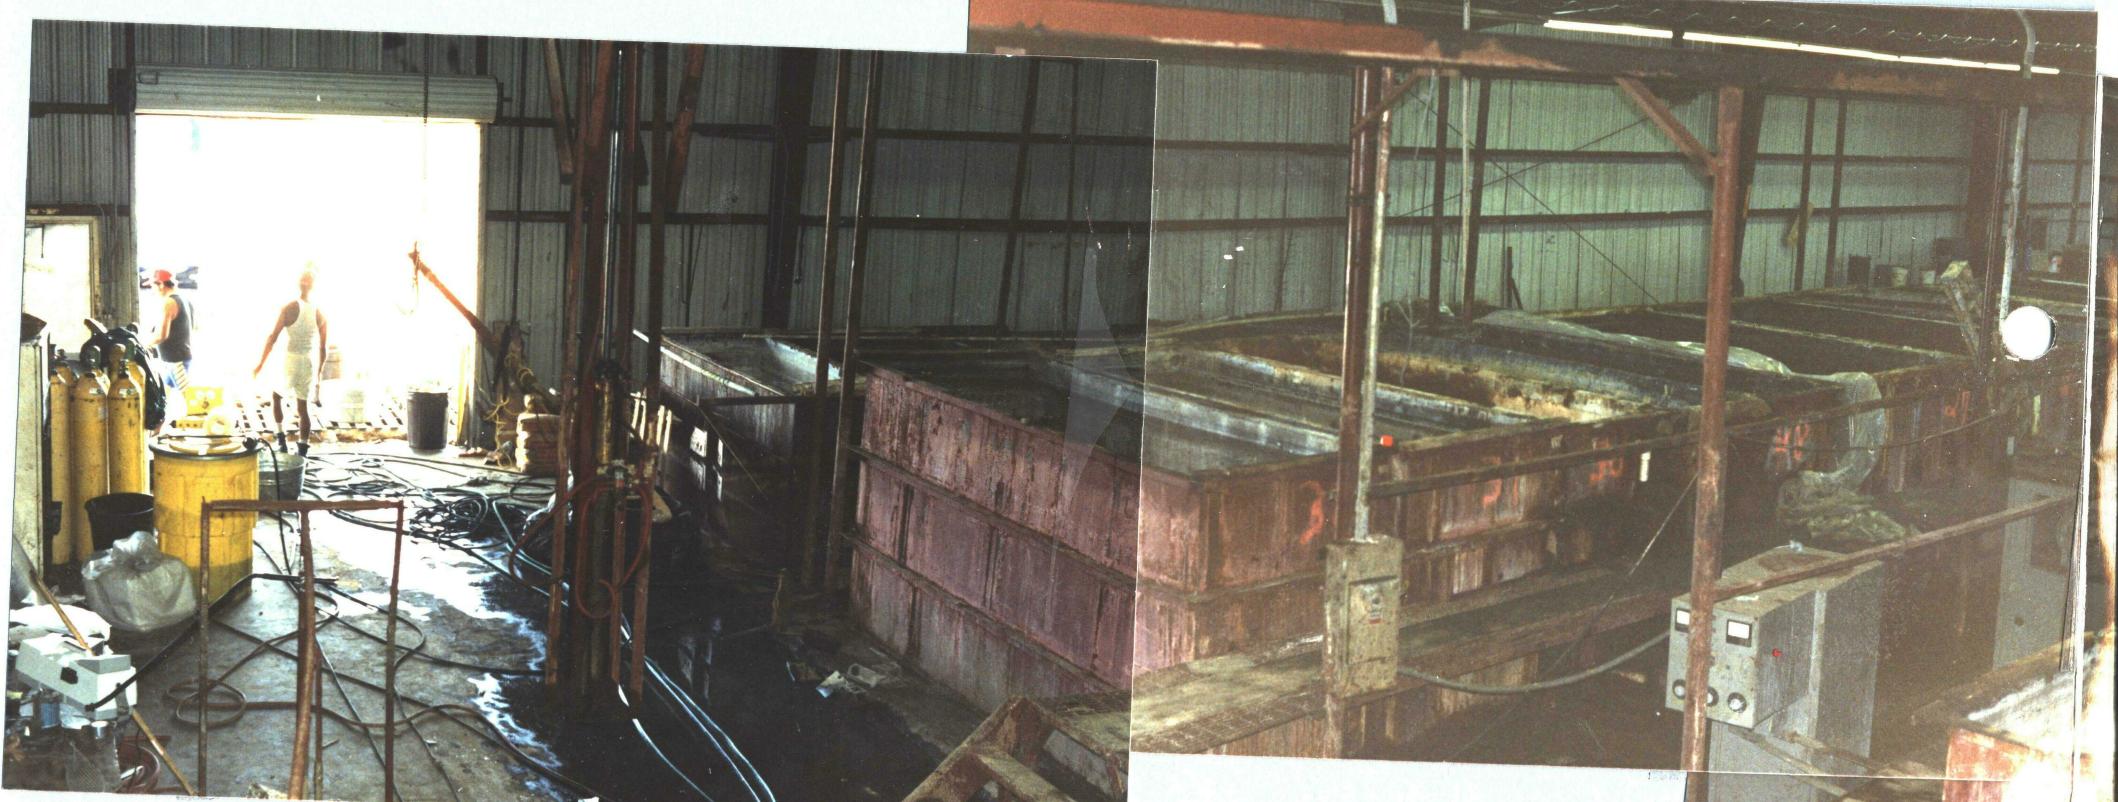
Comments: Pan shot of vats before vat
final rinsing.

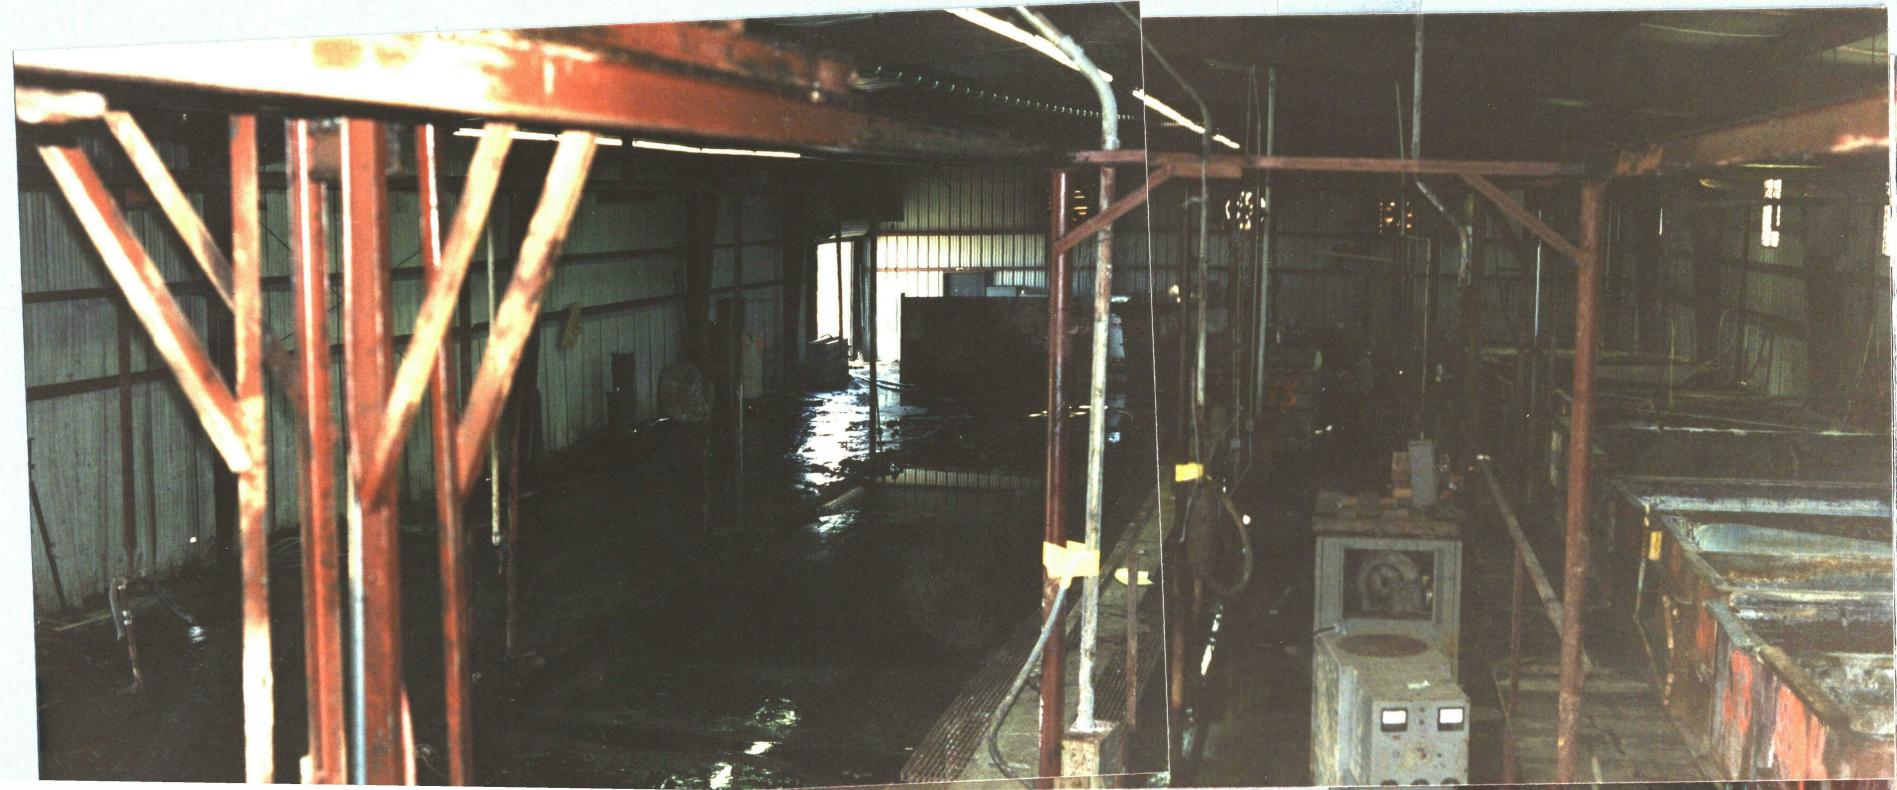
Comments: Warehouse after initial removal
of vats.

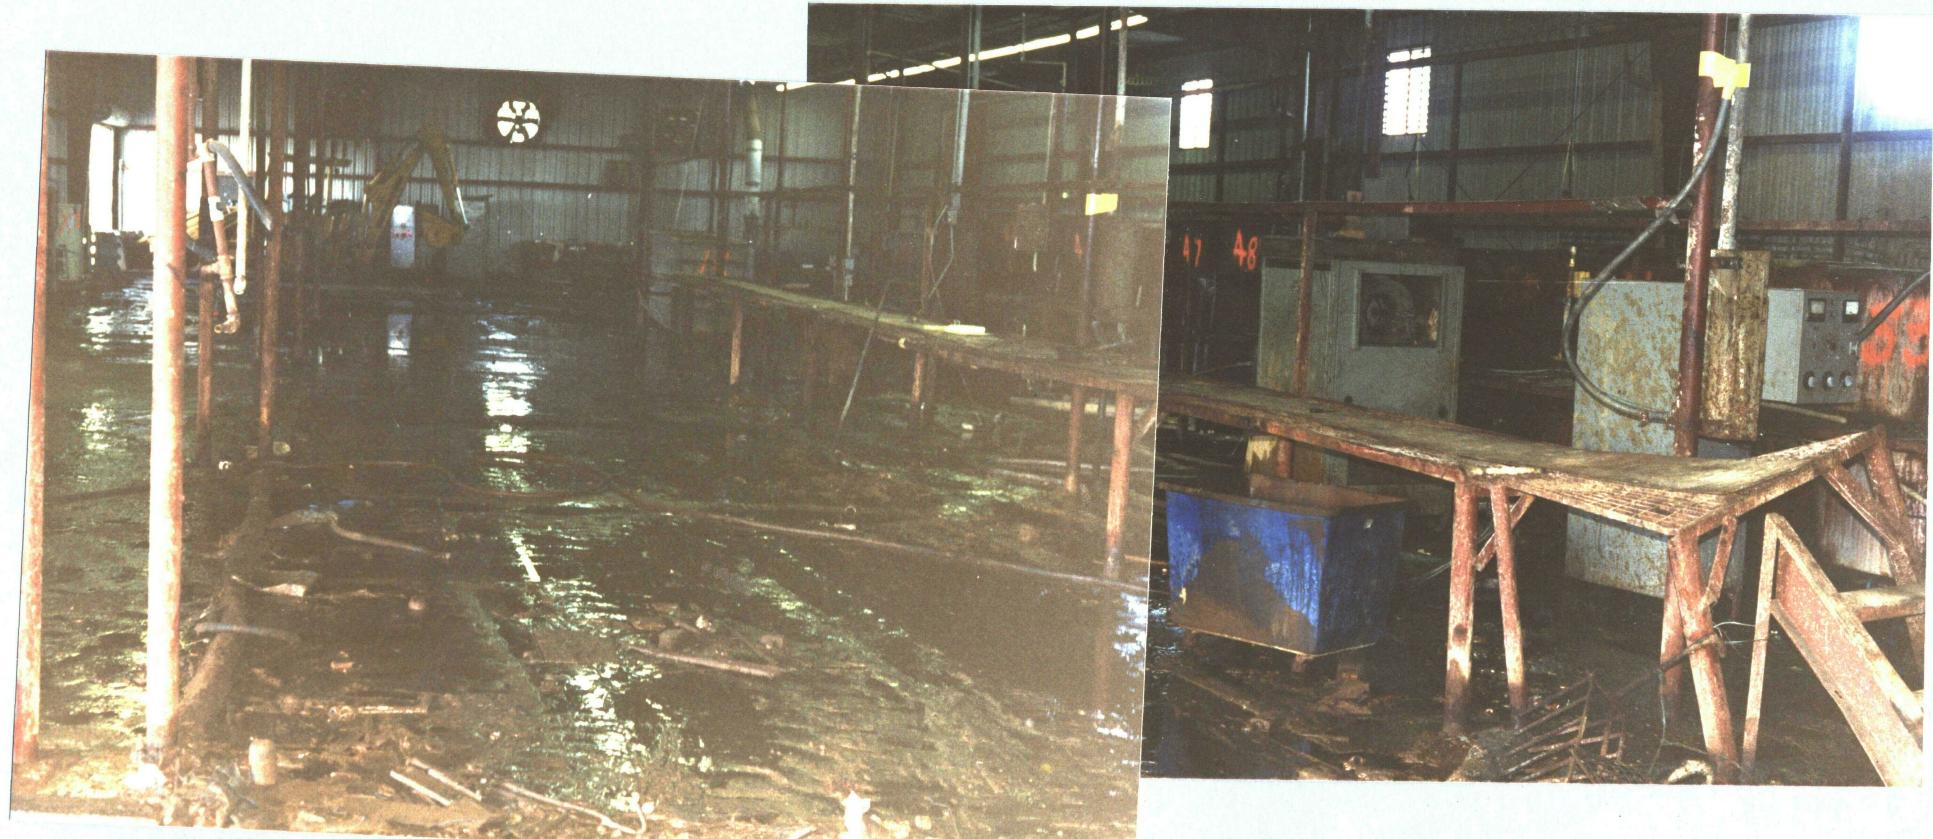
Comments: Floor of warehouse after vat removal.

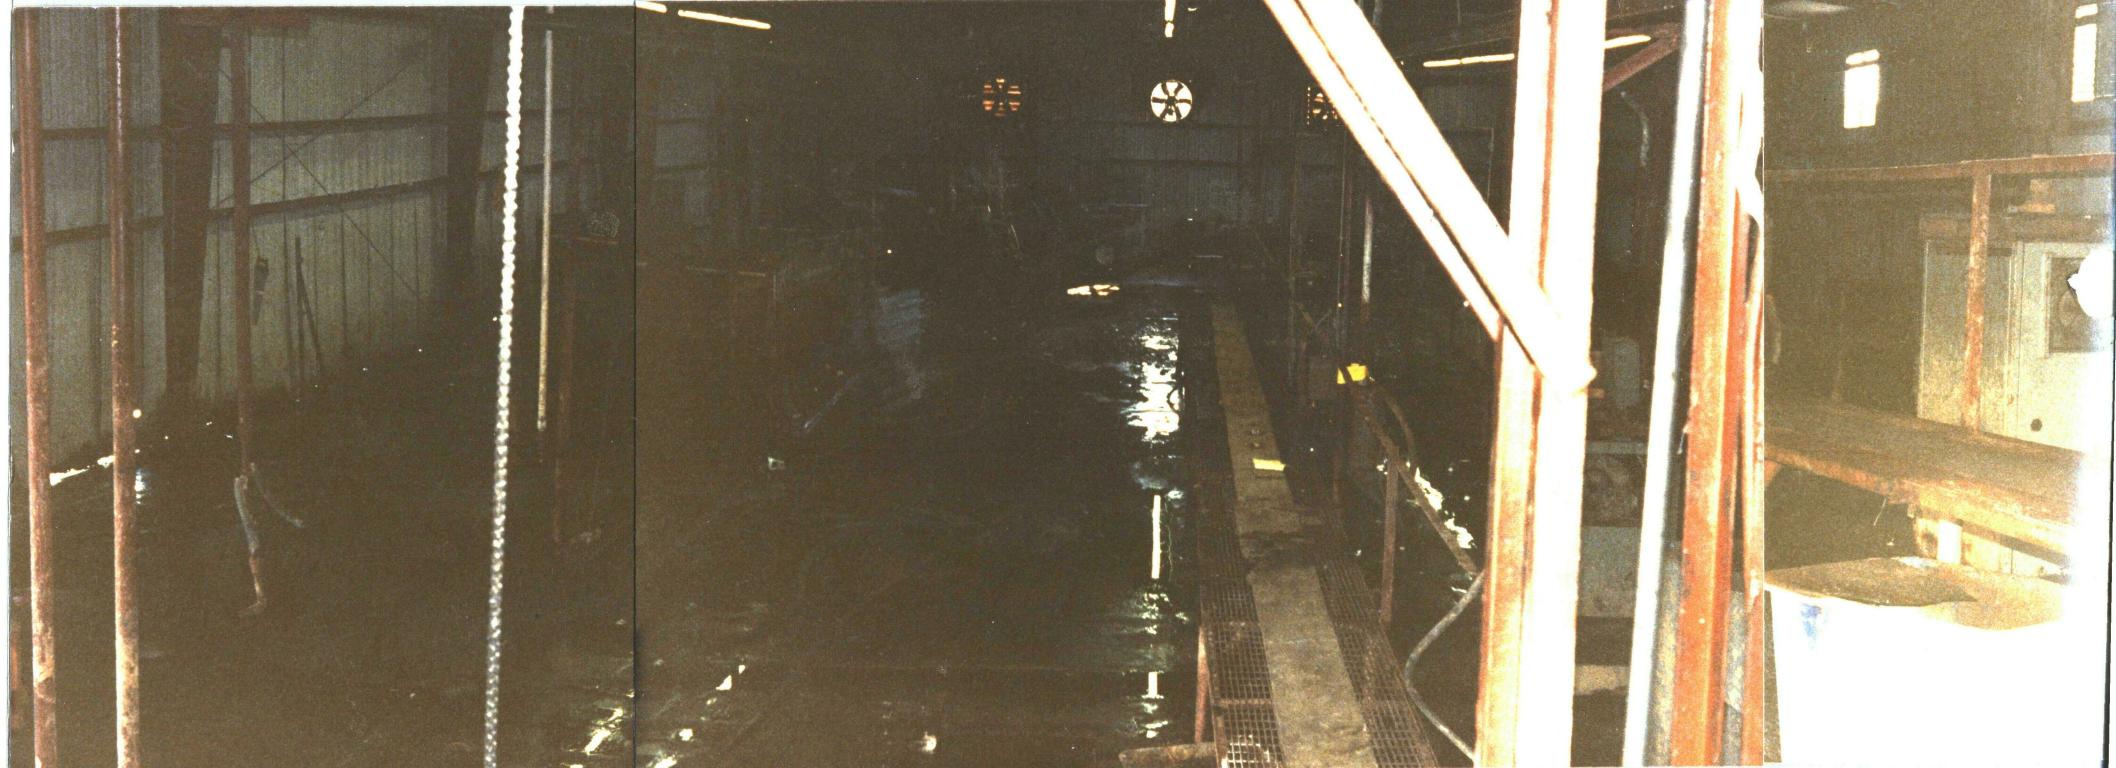
Comments: Pan shot of warehouse after
all the vats were removed.

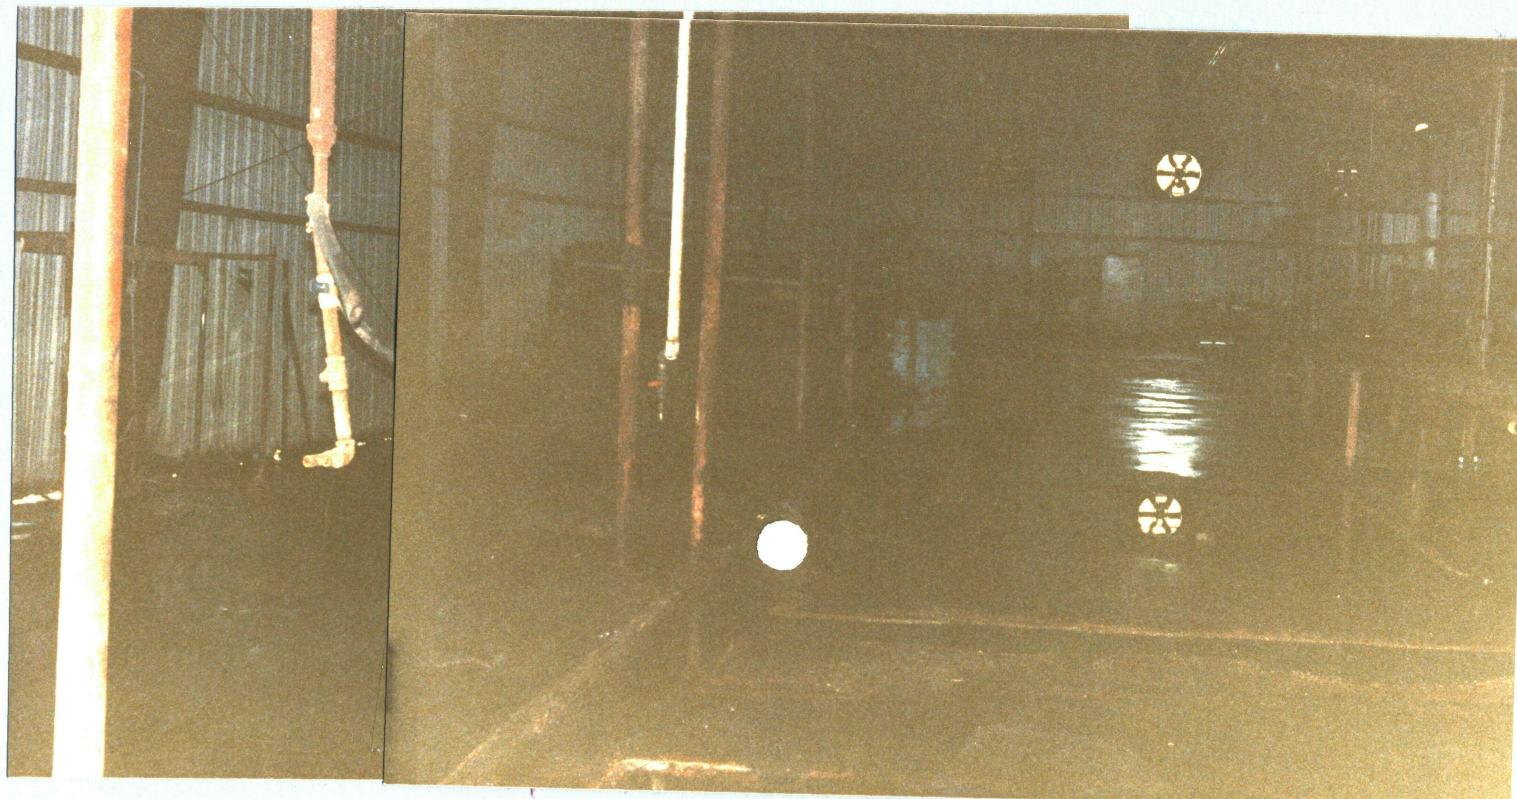
Comments: Warehouse after the completion of the removal.
